Airfield Damage Repair Modernization Program

AM2 3-4 Alternate Lay Pattern Evaluation

September 2014

Final report

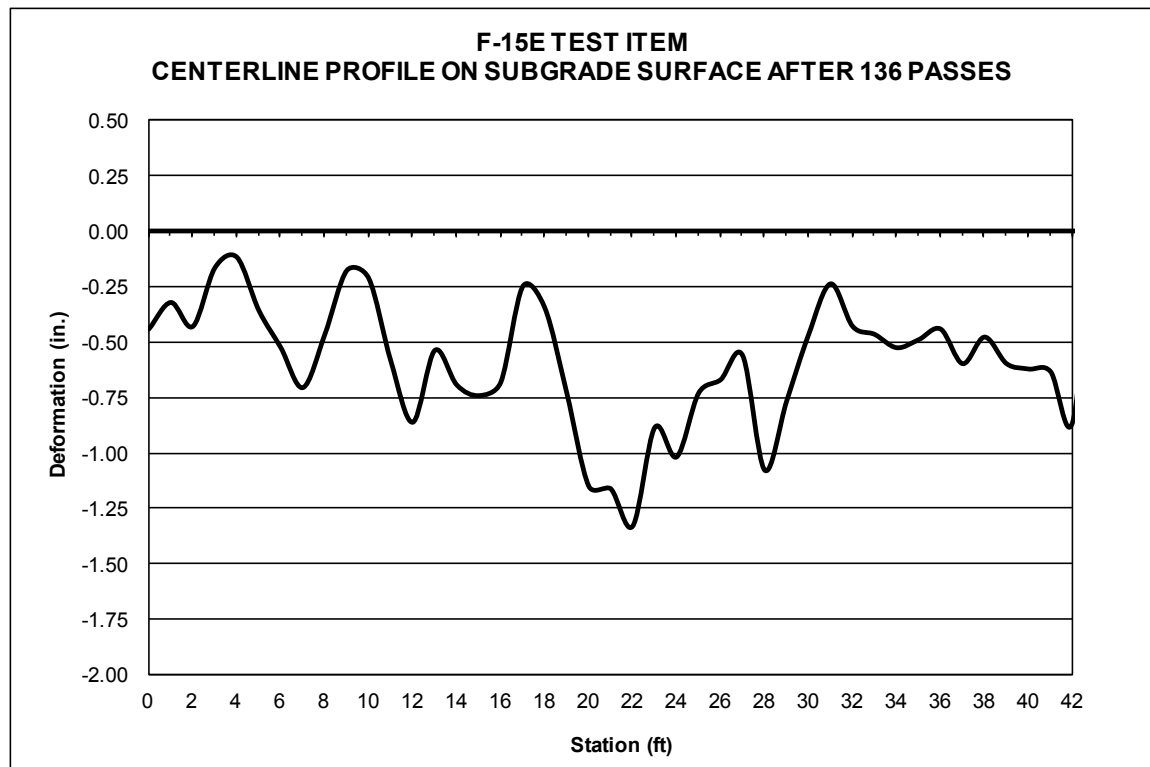
Figure 36. Subgrade centerline profile of the F-15E item after 136 passes.

Plots of the centerline profile data, as determined from robotic total station recordings, for the F-15E and C-17 test items are shown in Figures 36 through 39. Maximum abrupt changes in elevation were determined by observing the difference in elevation of data points within two stations of each other and choosing the maximum value for each plot. Each maximum value was then used for comparison to the roughness criterion.

Plots of the average cross-section elevation data, collected along lines A1, A2, and A3 shown in Figure 28 for each test item, are shown in Figures 40 through 45. Maximum deformation values for the subgrade, loaded, and unloaded cross sections were determined as the difference in elevation from the average height of the elevated material on each side of the trough to the deepest point in the bottom of the trough. Table 9 summarizes maximum deformation values measured on each item for profiles and cross sections.

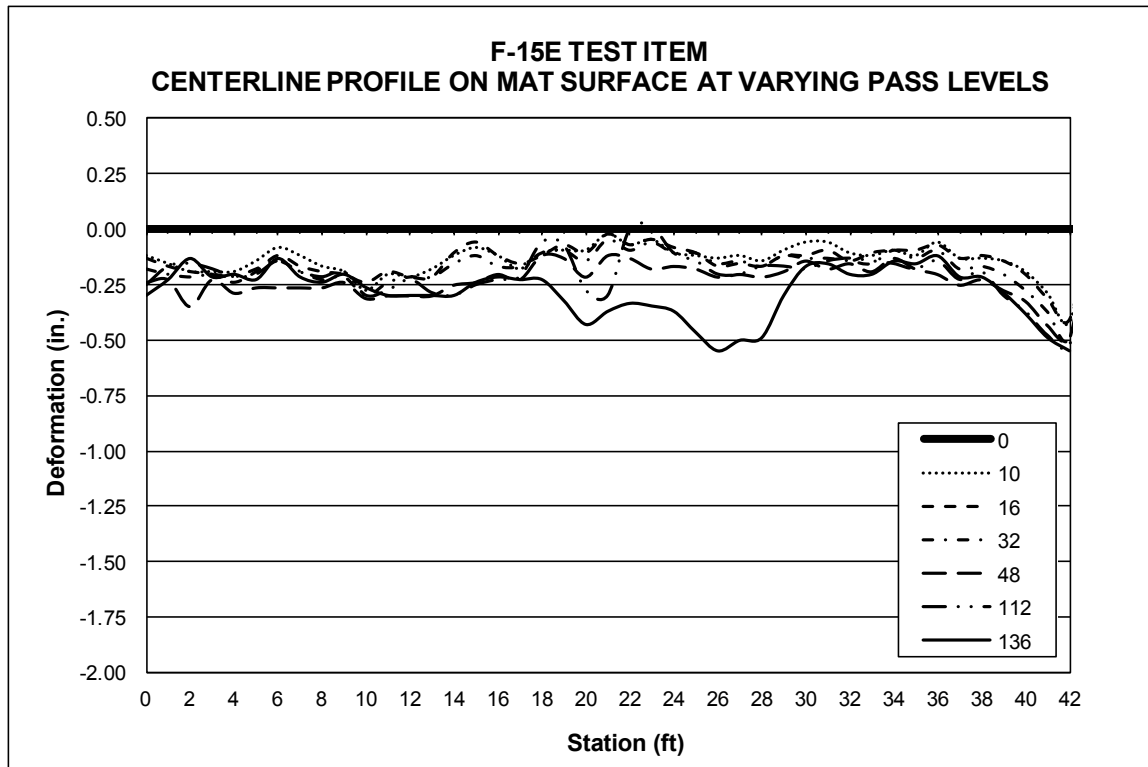
Figure 38. Centerline profile on the mat surface of the F-15E item.

The centerline profiles for the post-traffic subgrade and the surface of the mat at various traffic intervals are shown in Figure 36 and Figure 38, and maximum values are reported in Table 9. Both profiles were analyzed to determine whether the roughness criterion was exceeded. The values in Table 9 are 0.90 in. and 0.32 in. for the subgrade and mat surface, respectively, and are below the 1.25-in.-deep maximum value established for roughness for F-15E aircraft traffic. Therefore, the system performed adequately to prevent excessive roughness from occurring along the profile during the application of 136 passes. Similar behavior was also documented in previous brickwork pattern tests over a CBR of 6 (Rushing and Tingle 2007; Rushing and Torres 2007).

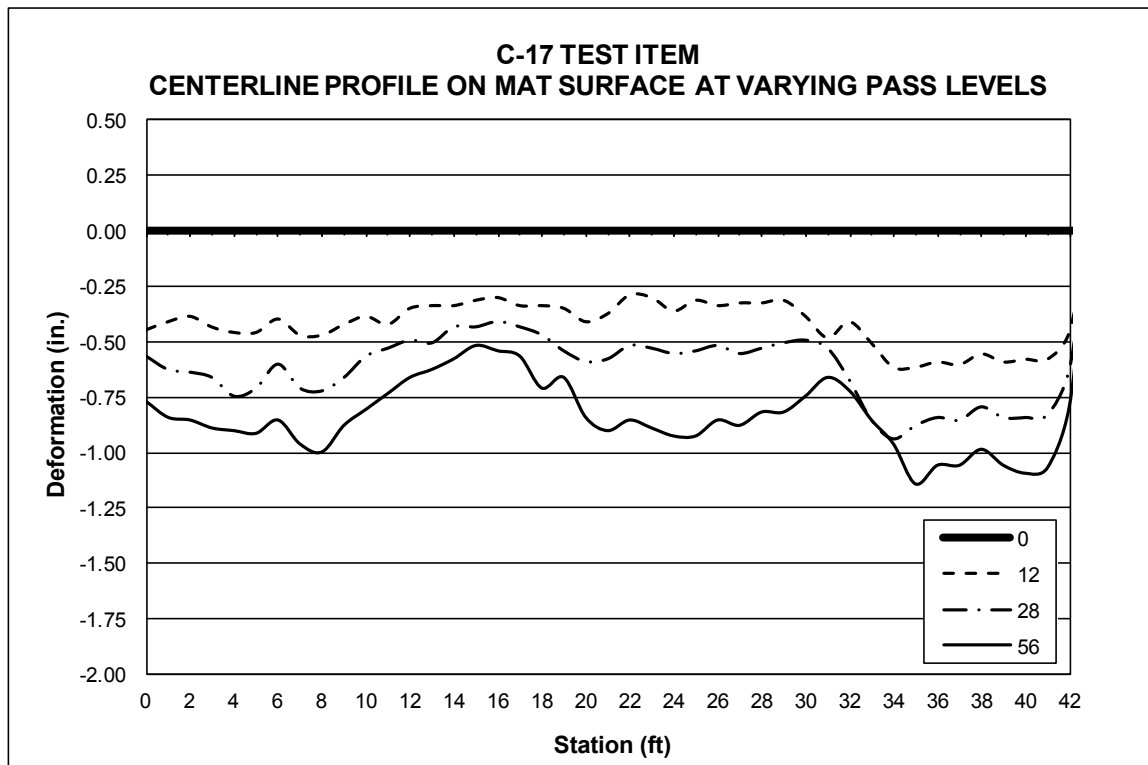
Figure 39. Centerline profile on the mat surface of the C-17 item.

The centerline profiles for the post-traffic subgrade and the surface of the mat at various traffic intervals are shown in Figure 37 and Figure 39, and maximum values are reported in Table 9. Both profiles were analyzed to determine whether the roughness criterion was exceeded. The values in Table 9 are 0.79 in. and 0.48 in. for the subgrade and mat surface, respectively, and are below the 3.0-in.-deep maximum value established for roughness for C-17 aircraft traffic. Therefore, the system performed adequately to prevent excessive roughness from occurring along the profile after 56 passes. Similar behavior was also documented in previous brickwork pattern tests over a CBR of 6 (Rushing and Tingle 2007).

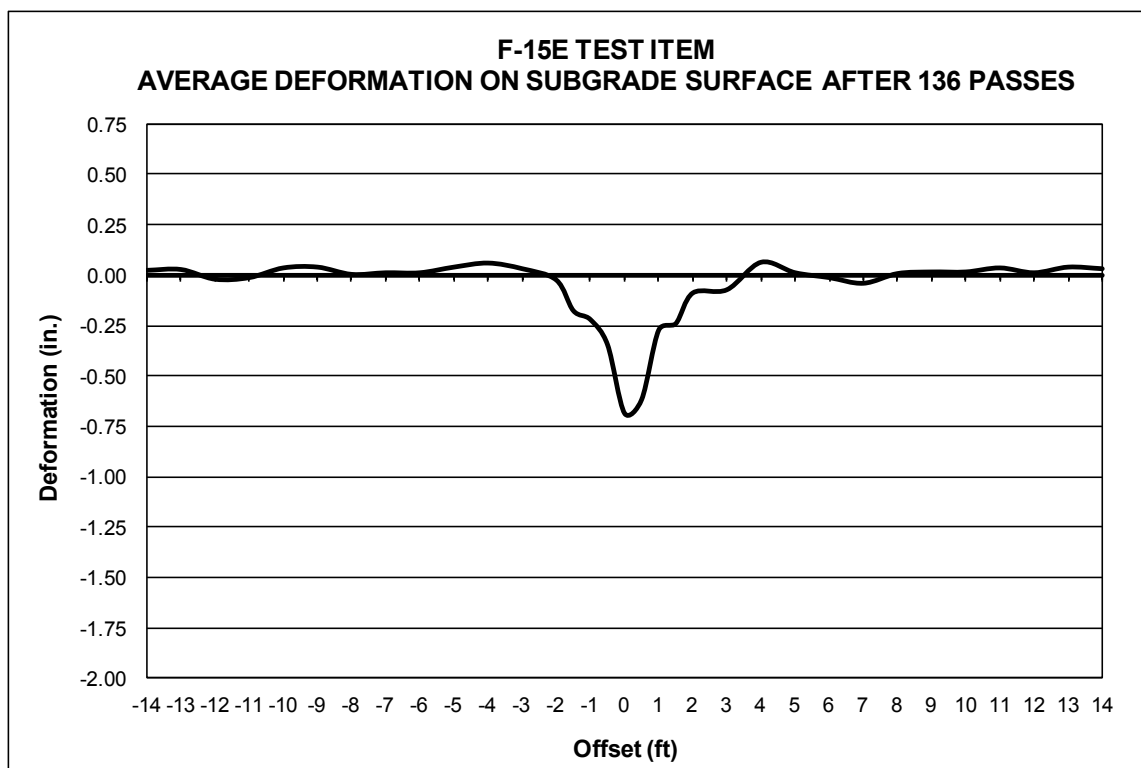
Figure 40. Average deformation on the subgrade of the F-15E item.

The permanent deformation on the subgrade, the loaded mat surface, and the unloaded mat surface is shown in Figure 40, Figure 42, and Figure 44, respectively. For the F-15E test item, the maximum permanent deformation after 135 passes was 0.74 in., 0.62 in., and 0.26 in. on the subgrade, loaded, and unloaded mat surface, respectively. The failure criterion of 1.25 in. was not exceeded. Therefore, the system performed adequately to prevent excessive roughness from occurring prior to failure by mat breakage. In previous tests over a CBR of 6 using the brickwork pattern, deformation limits were exceeded around 1,500 passes.

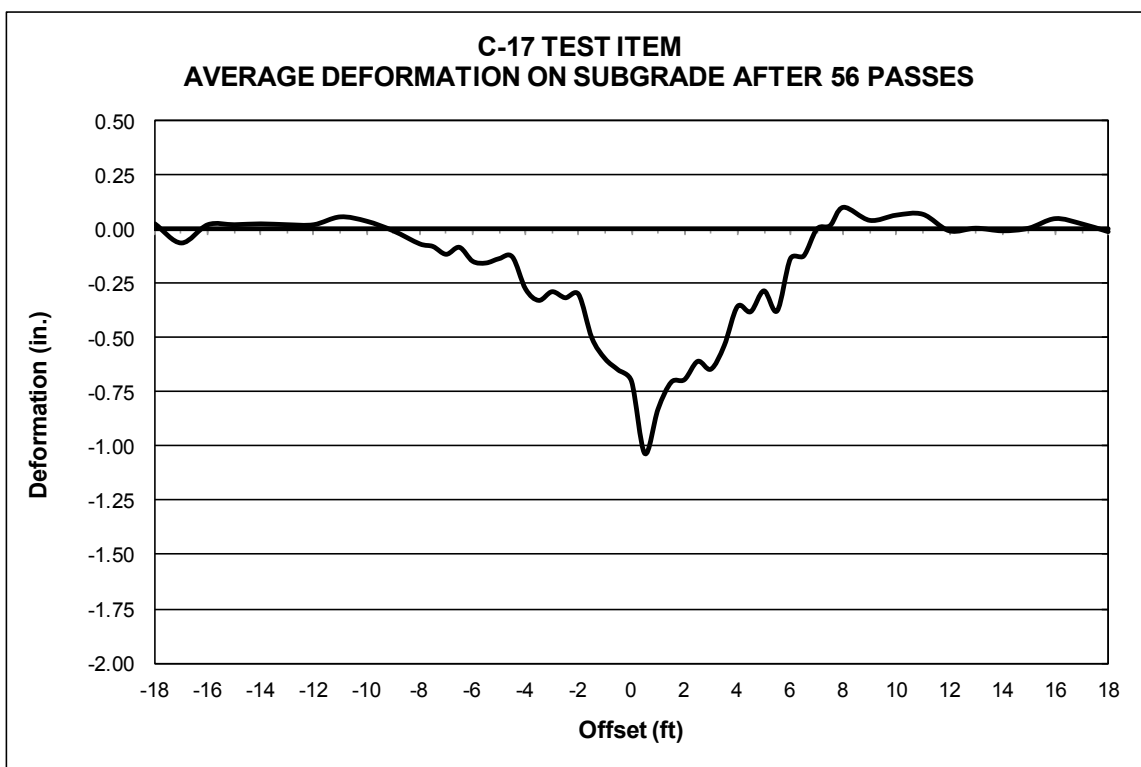
Figure 41. Average deformation on the subgrade of the C-17 item.

The permanent deformation on the subgrade, the loaded mat surface, and the unloaded mat surface is shown in Figure 41, Figure 43, and Figure 45, respectively. For the C-17 test item, the maximum permanent deformation after 56 passes was 1.11 in., 0.95 in., and 0.85 in. on the subgrade, loaded, and unloaded mat surface, respectively. The failure criterion of 3.0 in. was not exceeded. Therefore, the system performed adequately to prevent excessive roughness from occurring prior to failure by mat breakage. In previous tests over a CBR of 6 using the brickwork pattern, deformation limits were exceeded around 1,500 passes.

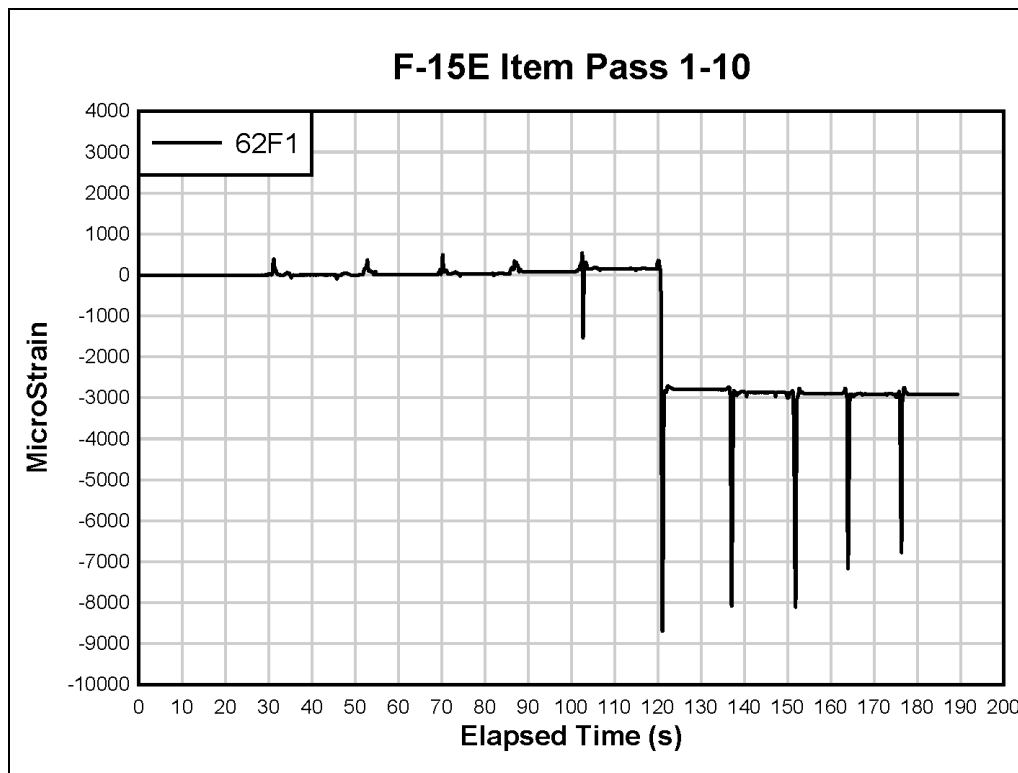
Figure 49. Strain gauge data for F-15E item, SG 62F1, passes 1-10.

Example plots of the strain gauge raw data for the F-15E and C-17 items are shown in Figure 49 and Figure 50, respectively. Figure 49 represents the response from the first 10 passes of F-15E traffic from a gauge installed on the upper underlap of Panel 62 (the first panel to fail). Each of the positive peaks represents tensile strains, and the negative peaks represent compressive strains. Each of the 10 passes can be associated with a measured peak. Since the distributed traffic pattern began on the east side of the gauge location, the gauge did not measure significant compressive strains during the first four passes. The data set validates that the load moved to the west

side of the joint on pass six, where there is a baseline shift indicating permanent deformation and large compressive strains. The changing magnitude of the peaks was caused by the wander pattern used to simulate a normal distribution of traffic over the test section. The higher peaks indicate that the load cart was located directly above, or adjacent to, the strain gauge.

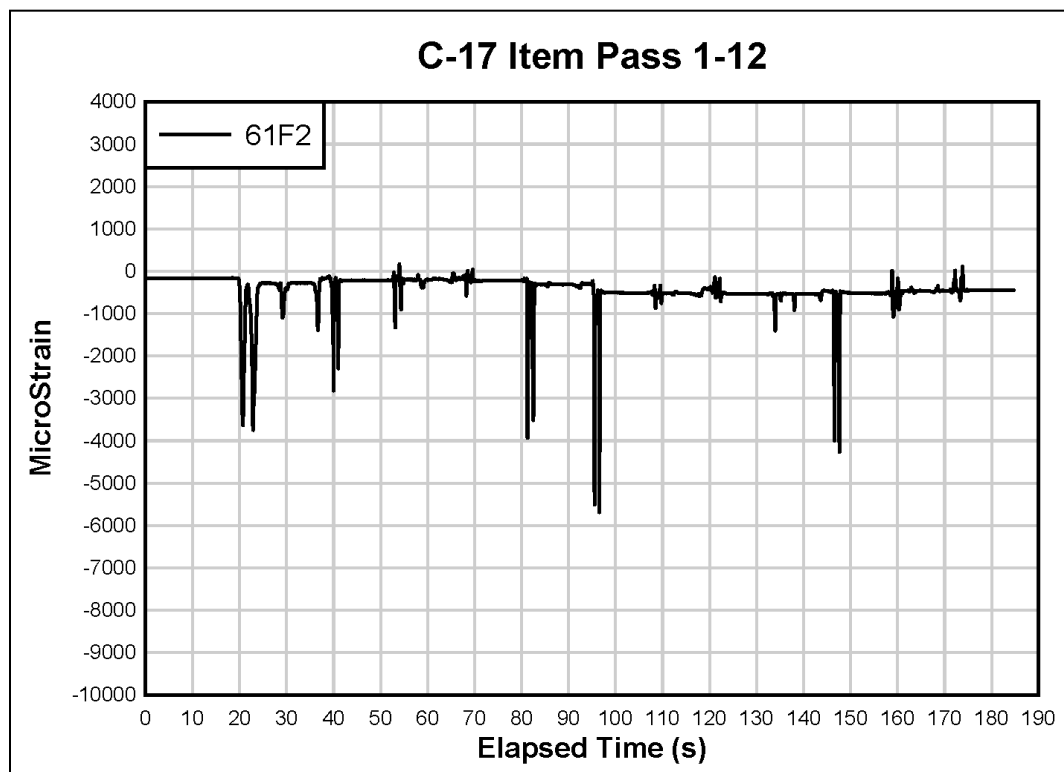
Figure 50. Strain gauge data for C-17 item, SG 61F2, passes 1-12.

Figure 50 represents raw data collected for the first 12 passes of the 6-wheeled C-17 load cart from a strain gauge mounted on the lower overlap of Panel 61 (third panel to fail). Each pass is indicated by two large peaks and one small peak, representing the two main axles of the C-17 and the drive axle of the scraper engine used to pull the simulator, respectively. The strain values generally show higher compressive strains for the first six passes when the vehicle was on the east side of the joint, and then the values tended to decrease when the vehicle moved to the west side of the joint. This reaction is exactly opposite of the effect shown in Figure 49 but is expected, since the opposing panel joints are represented. As described for Figure 49, the magnitudes of the peaks also indicate the wander pattern used in the test, but it is not as obvious, since six load wheels are being applied instead of one.

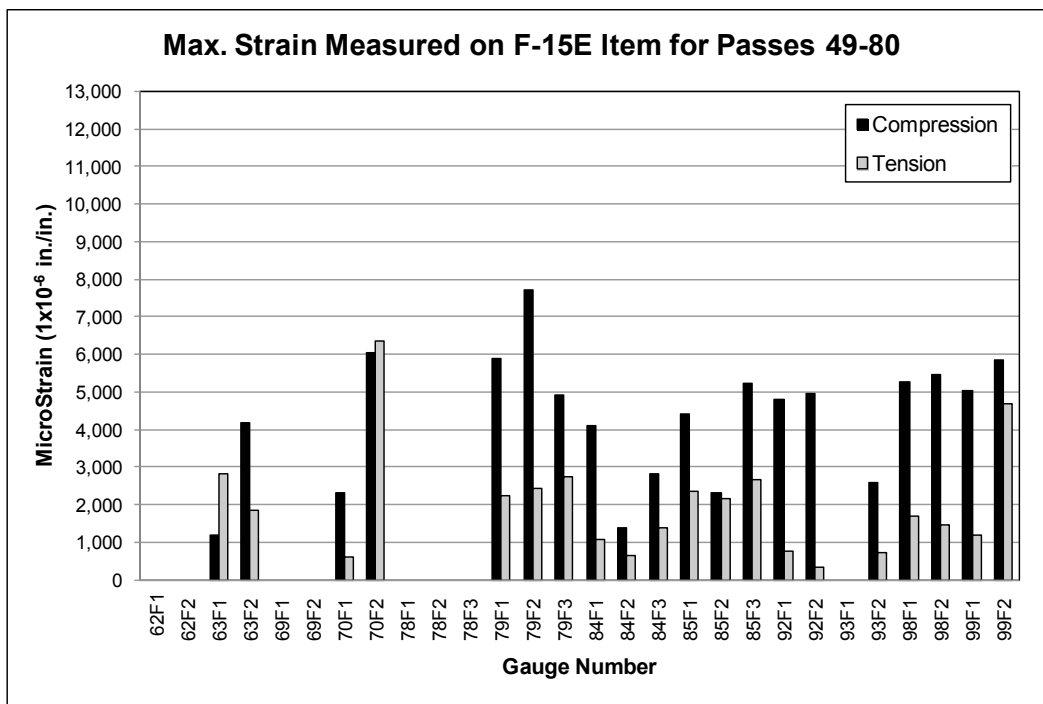
Figure 55. Strain gauge data for F-15E item, passes 49-80.

For the F-15E item, Gauge 93F1 failed to function during the test. From Table 7, Panels 62, 69, and 78 failed in the range of 49 to 80 passes as indicated by their disappearance beginning in Figure 55. After the failures, the strains measured on the opposing panels, 63, 70, and 79, were significantly reduced as shown in Figure 56, validating the stress relief in the lower overlap after the upper underlap broke free from the adjacent panel. Other significant inferences from the F-15E data were that the strain magnitude increased, as shown for gauges on Panels 63 and 98, near the bridging panel boundaries from Panels 57 and 104, and strain values increased because of load transfer to successive panel sets after a failure.

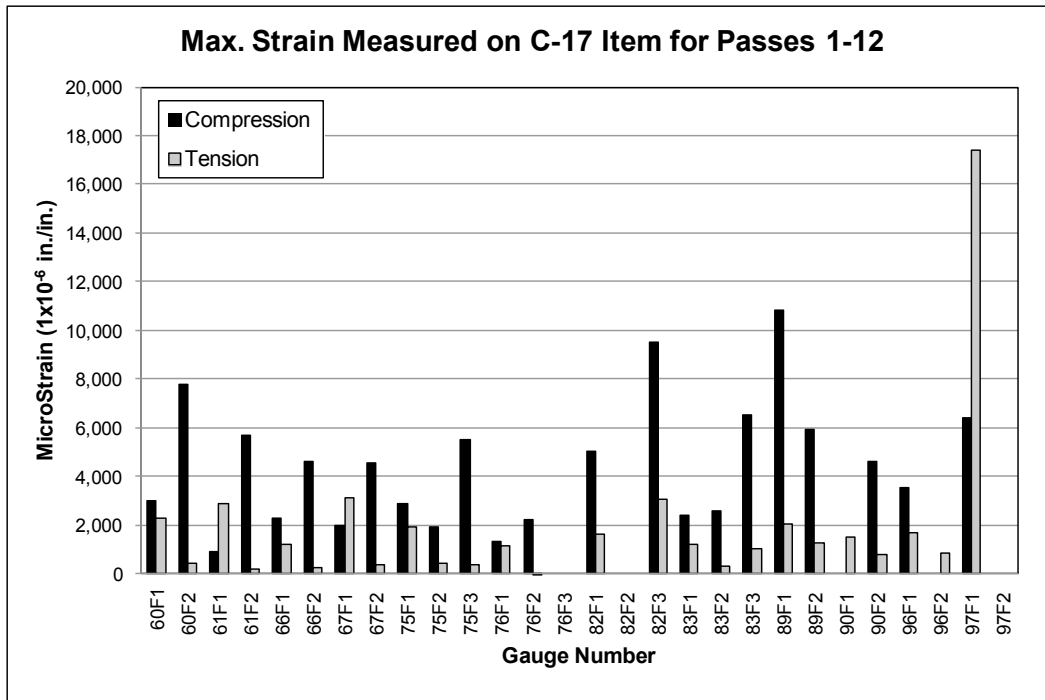
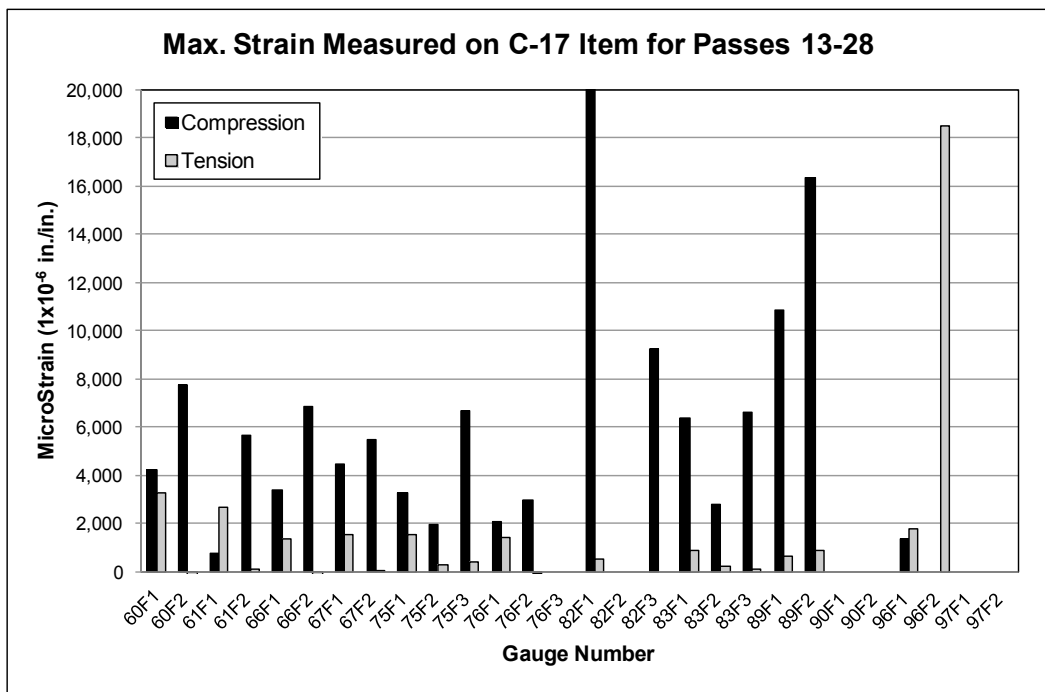
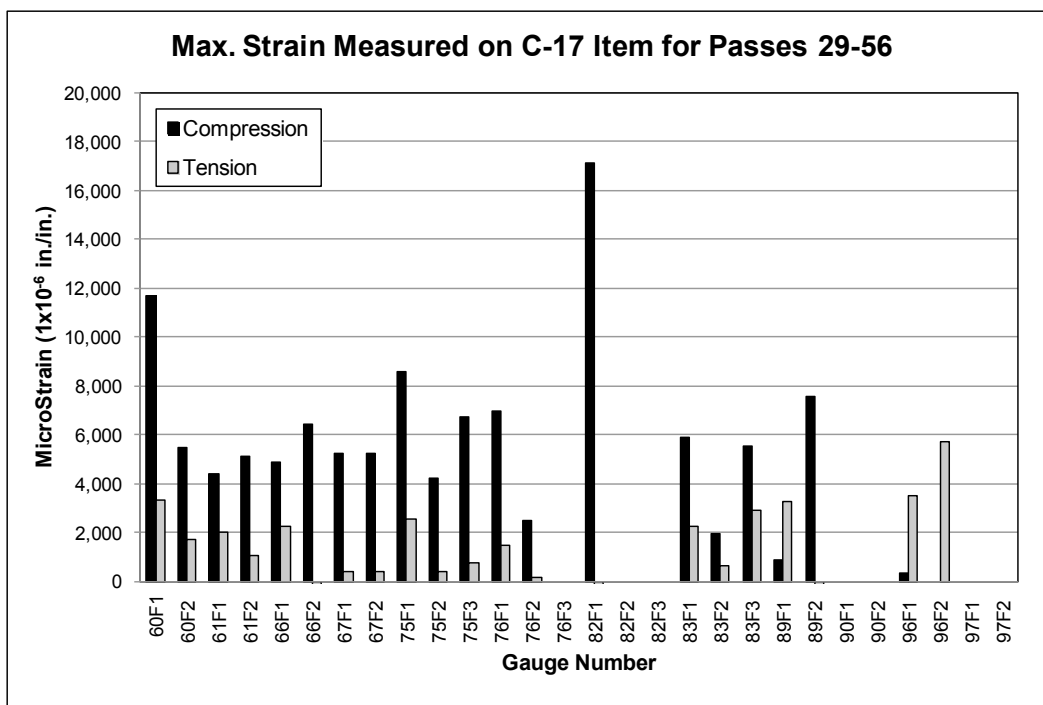
For the C-17 item, Figure 60 through Figure 62 show that gauges 76F3, 82F2, and 97F2 failed to return any usable data. According to Figure 61,

data indicate Panels 90 and 97 failed between passes 13 and 28, although visual observations reported failures at 28 and 56 passes, respectively. The strain gauge data may be able to show that failure occurred earlier than noted from visual observations or that high strains may have destroyed the gauges prior to failure. Most likely, the gauge failures are directly linked to mat breakage. The raw strain data validated that Panel 83 failed at 46 passes, and Panels 61, 67, and 76 all failed at 50 passes. The values shown in Figure 62 show the strain magnitudes for these four panels prior to failure. Overall, the measured strains in both test items appeared to yield usable results for the DIM and other future modeling efforts.
